# Failure mechanism and behavior of a large landslide in glacio-lacustrine silt and clay, Chilliwack River Valley, B.C.

Lara Fletcher, Oldrich Hungr, Andrew Watson

**Abstract:** The Slesse Park landslide is a very large, natural instability in stiff, glacio-lacustrine silt and clay on the north side of the Chilliwack River, 600m upstream from the community of Slesse Park.

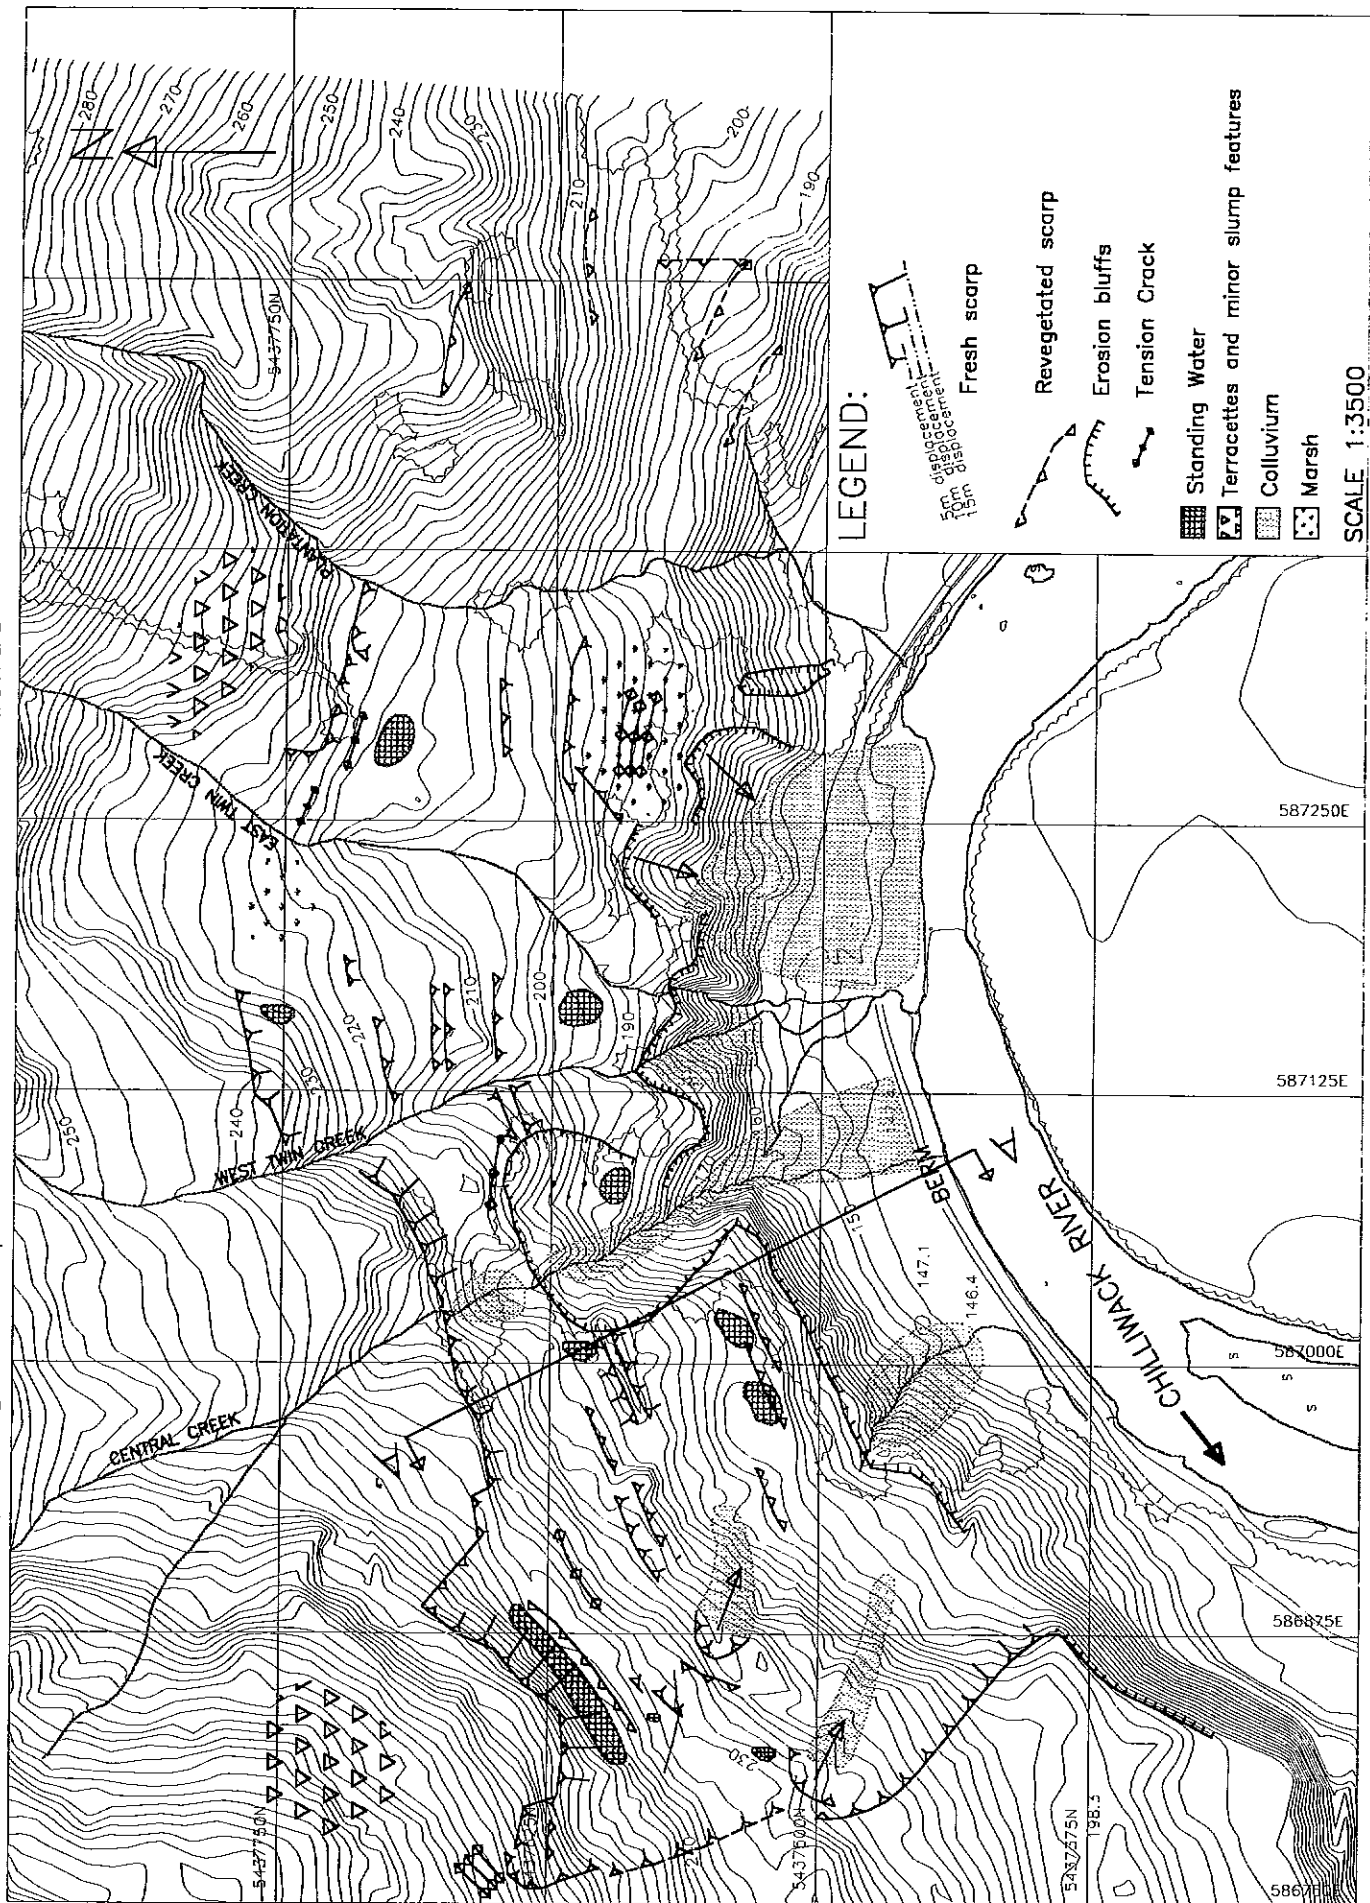
FIGURE 2. Geomorphological Map of the Slesse Park Landslide

A relatively continuous back scarp defines the upper limit of the landslide. It consists of steep, freshly exposed soil scarps that vary in height from 2 to 15m. The main body of the slide appears to be moving forward towards the river over a distinct failure surface located within the laminated silts and clay of Unit 4 (approximate El. 178m). This sliding surface is knife-edged and can be traced for almost 500 m along the river escarpment. It is an extremely smooth slickensided discontinuity dipping 1° to the west (Fig. 4, Fig. 5). The displaced material above

Fresh soil exposures, thrown trees, and stressed vegetation including stretched roots are evidence to indicate recent to very recent movement in the headscarp area over a distance of more than 500m. However, the ground surface between the freshly disturbed back scarp and the slide toe is forested and shows relatively few signs of fresh disturbance, suggesting that the main body of the slide is moving forward largely as a rigid blocks with some internal deformation. Fig. 3 shows a cross section of the slide observed just west of Central Creek. This figure includes a reconstruction of the rupture surface consistent with the morphology of the slide features. The rupture surface can be described as a compound sliding surface (Hutchinson, 1992). It cuts steeply from the ground surface to a subhorizontal bedding plane then follows the bedding plane until it daylights at the bluff face. At the rear of the slide, back tilted blocks covered by mature vegetation suggest rotational movement has occurred. In the lower slide area, a prominent ridge feature observed at approximately El. 215 suggests translational sliding. Laminations within the failure prism of this ridge dip 5° into the slope.

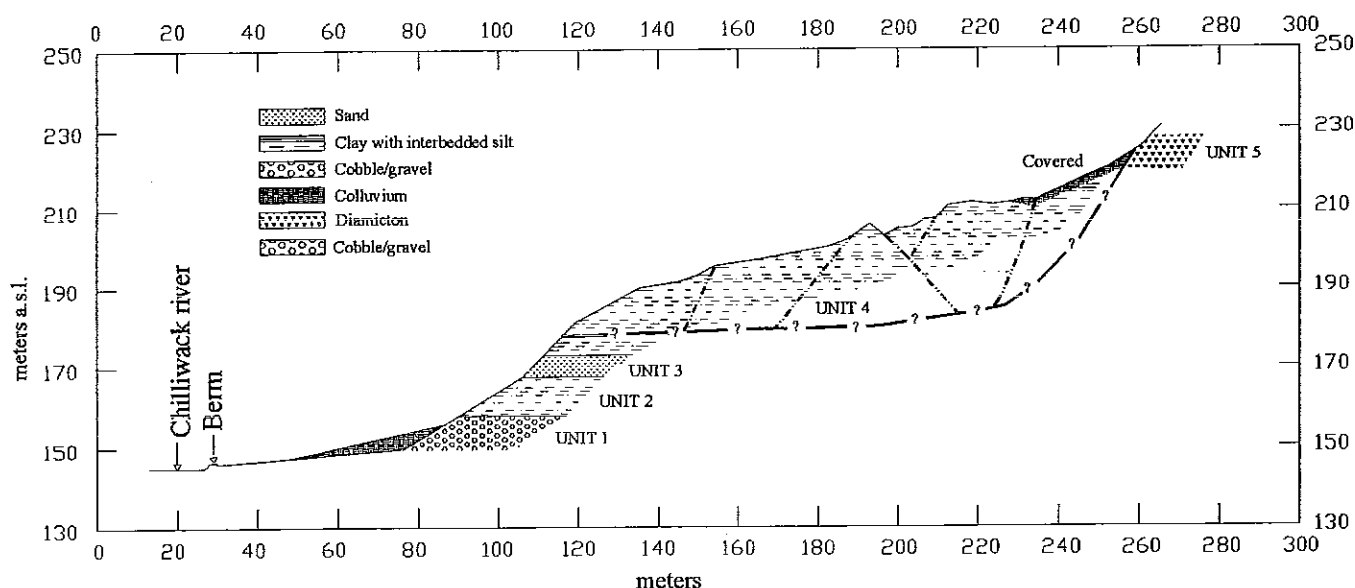
Fig. 3. Cross-section A-A' of Slesse Park landslide (See Fig. 2). Lateral extent of stratigraphic units is not known.

A summary of the quaternary stratigraphy interpreted from exposures along Central Creek gully and the main back scarp (Watson, 1999 and Clague et al. 1988) is shown in Fig. 3.

Unit 4 is glacio-lacustrine laminated silts and clay similar to Unit 2. The main failure plane is located within this Unit at El. 178 approximately, 5m above the base of Unit 4. Above the failure plane, a zone several metres thick has been remoulded. Above this zone the clay and silt is again laminated with bedding dipping 4 to 20° into slope suggesting varying degrees of backward rotation. This unit exhibits a coarsening upward sequence with the upper 2m grading from silt to uniform, fine grained sand.

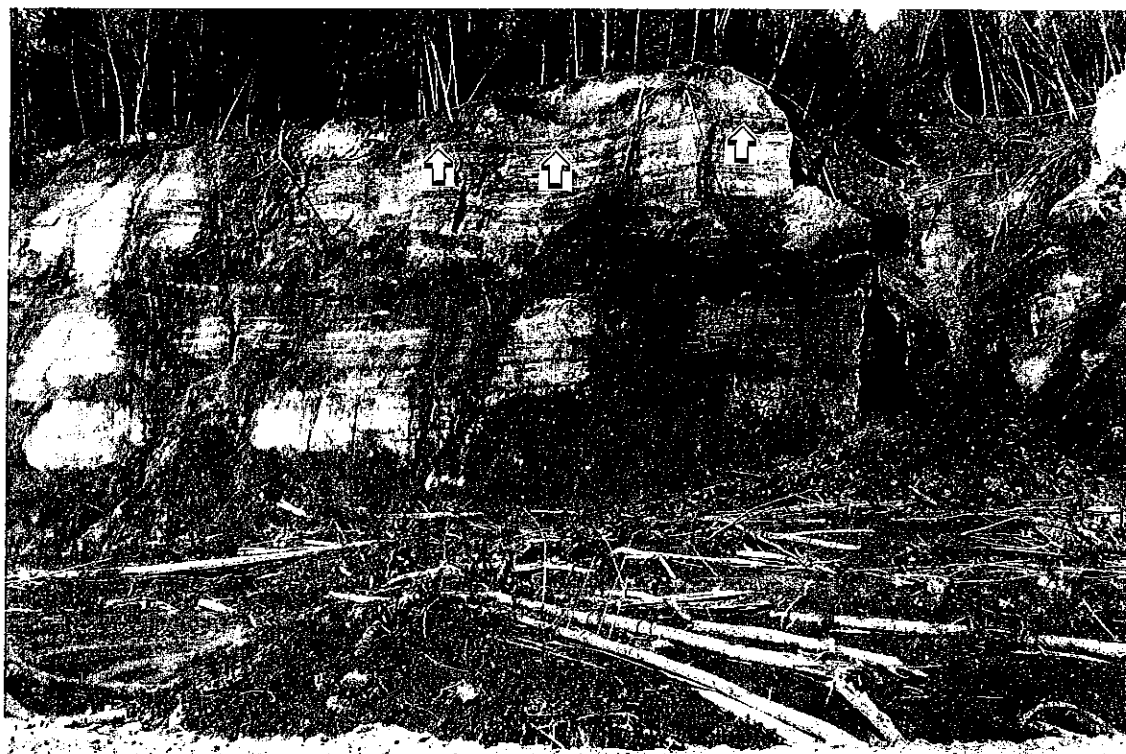
**Fig. 4.** Bluffs exposed along River. Note the location of the main failure plane.

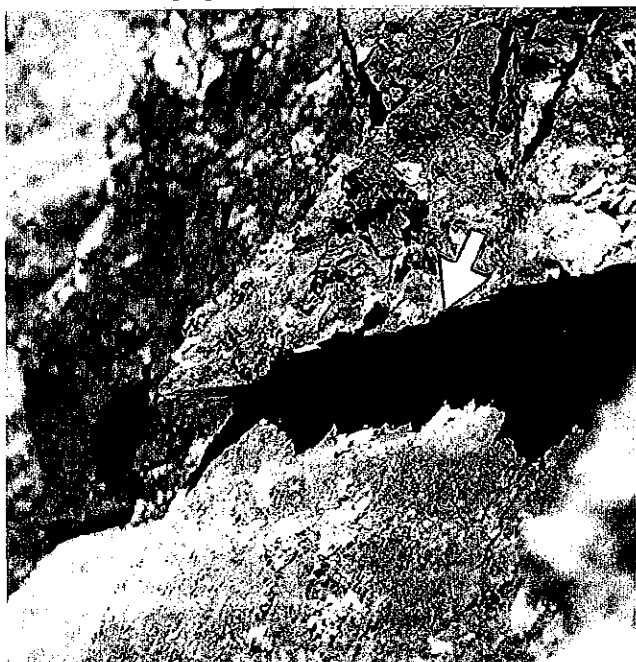
**Fig. 5.** Slickensided surface of main failure plane. Photograph shows an area 30cm x 30cm.

The clay layer that contains the slickensided failure surface is uniform, light grey and approximately 1cm thick. Of the materials tested, this clay shows the highest plasticity (PI=32%) and the highest clay content (66%). Material sampled within 4cm below the slickensided surface has a lower plasticity (PI=17%) and clay content (26%). A fine sand 1.5cm thick overlies the failure surface. Material sampled from 0-4 cm above the sand was remoulded. The plasticity of this material was between that of the undisturbed material below the sheared clay surface and the clay material in which the main failure occurs.

Given that large displacements of the main unstable mass have occurred, it is assumed that the weak surface is at its residual strength. Therefore, for the purposes of slope stability calculations, a residual friction angle of  $12^\circ$  was assigned to the highly plastic clays that the weak surface exploits (Thurber, 1997).
