Fountain Slide: An Overview

CN Ashcroft MP 109.4

CN Albreda MP 55.3 (Robson Valley)

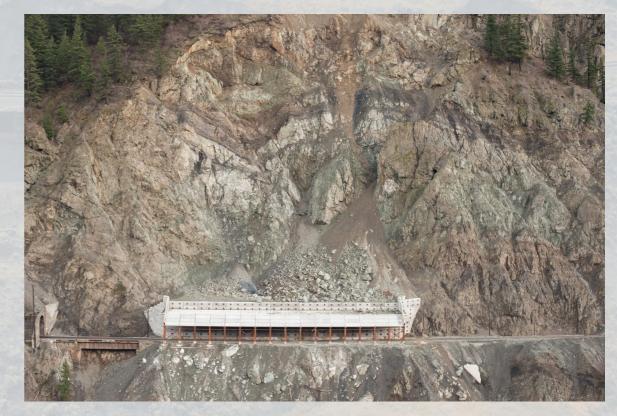
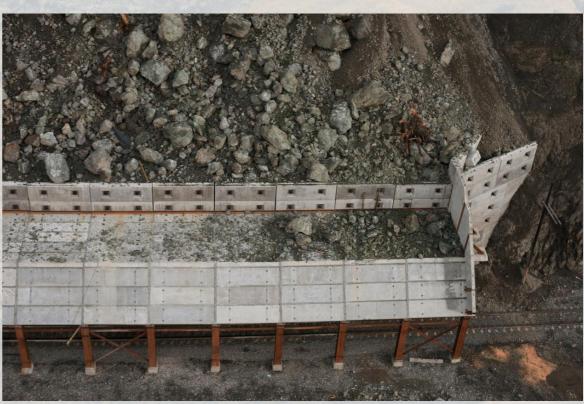
Project Test Site: Ashcroft MP 109.4

- 200 km from Vancouver, 50 km north of Hope on the Trans Canada (Jackass Mountain)
- Numerous rock fall failures
 - 50k m³ rock fall Closed the railway for 4 days in December 2012
- TLS data collection began in December 2013

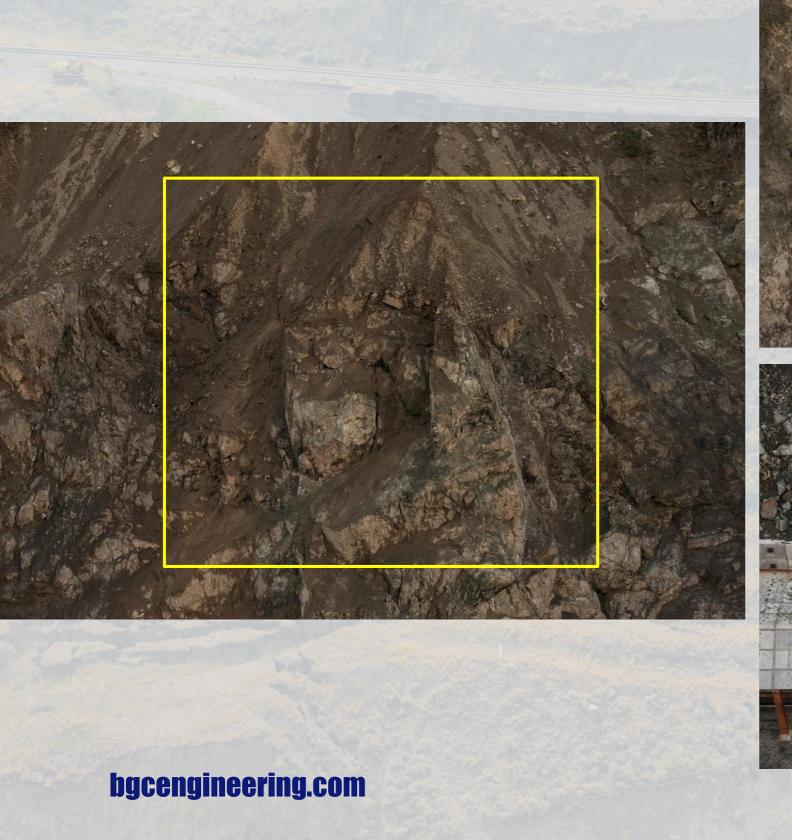
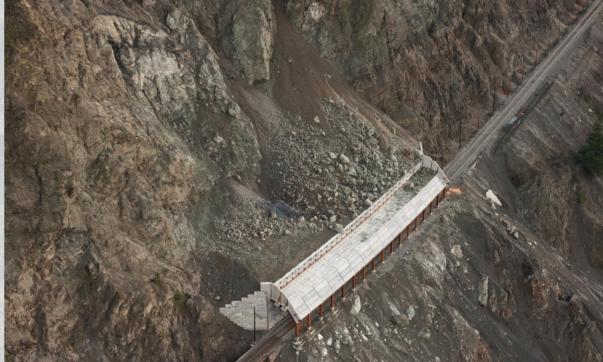
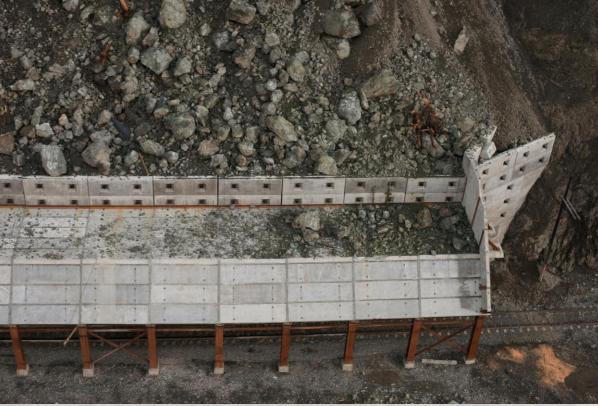
Failure Event
